Re: San Jacinto River Waste Pits Superfund Site
U.S. EPA Region 6, CERCLA Docket No. 06-03-10 UAO for RI/FS

Project Number: 090557-01.06

Post TCRA Site Map Showing Stockpile and Ramp Areas Utilized During Construction San Jacinto River Waste Pits Superfund Site

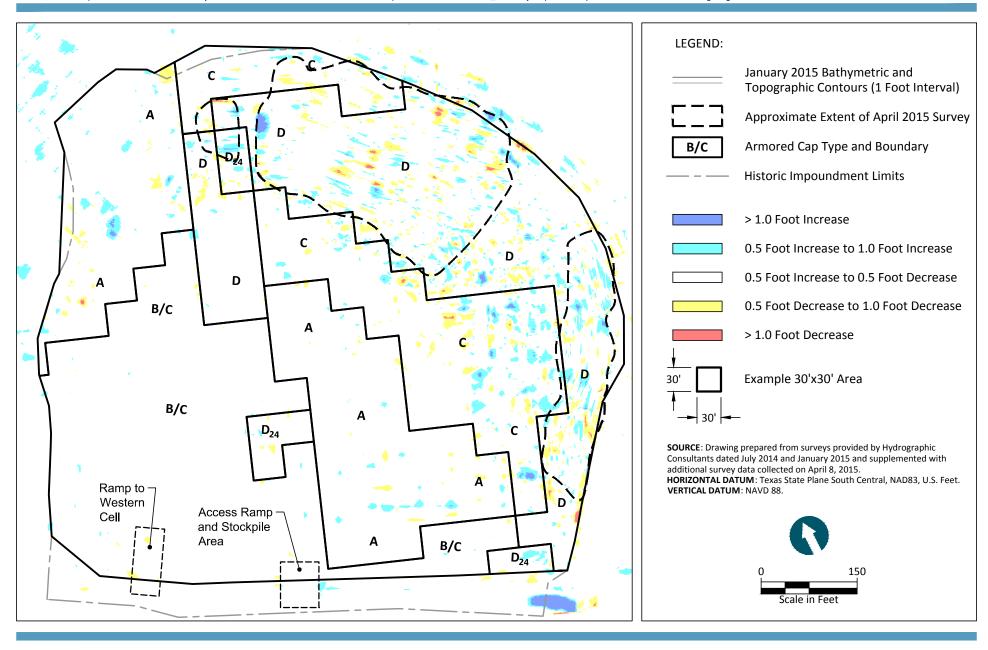
Figure 1

As pointed out by Mr. Mears during the June 15, 2015 inspection, there are other similar areas of the armored cap in which multiple layers of geotextile were used as protective measures during construction. In particular, this condition exists at the ramp/entrance into the central part of the western cell (as shown on the attached Figure 1).

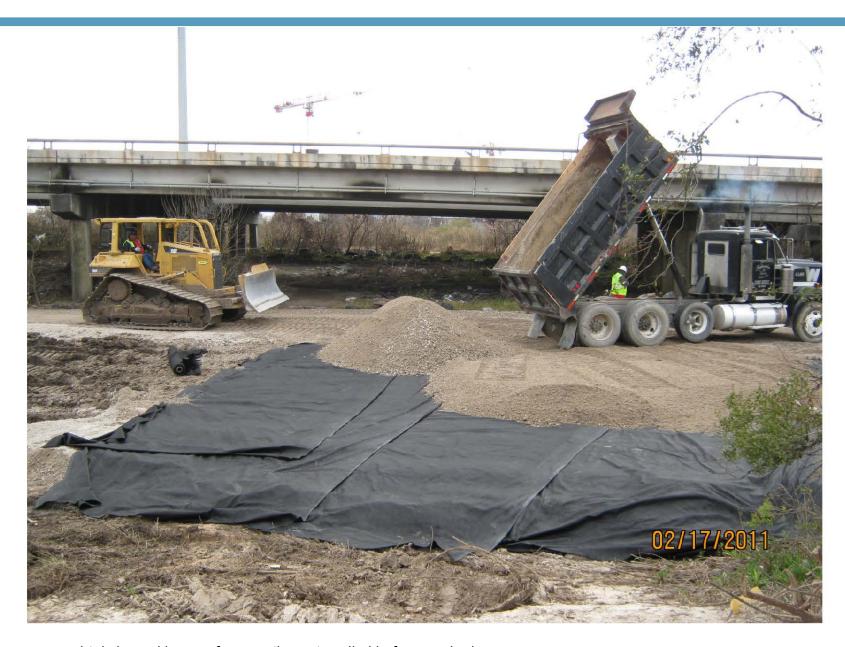
Note multiple lapped layers of geotextile are installed before crushed stone aggregate.

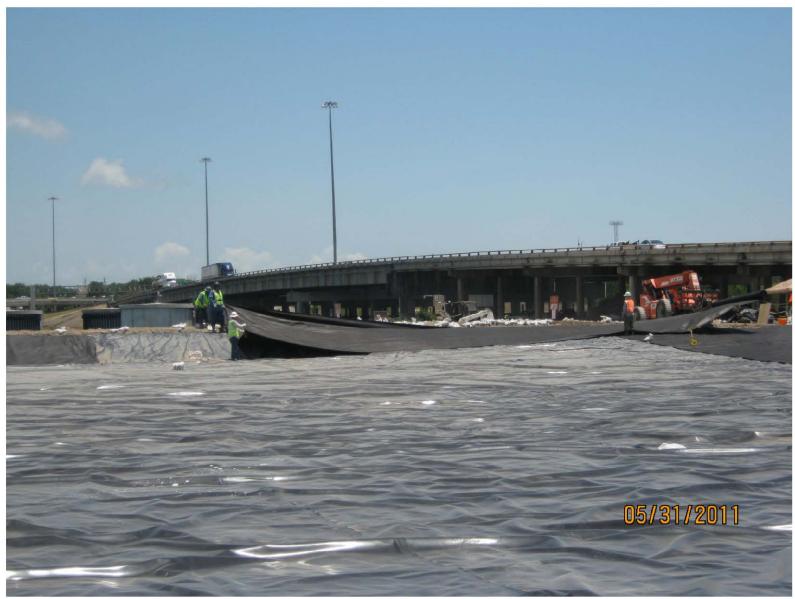
Looking southeast toward the stockpile area on the central berm.

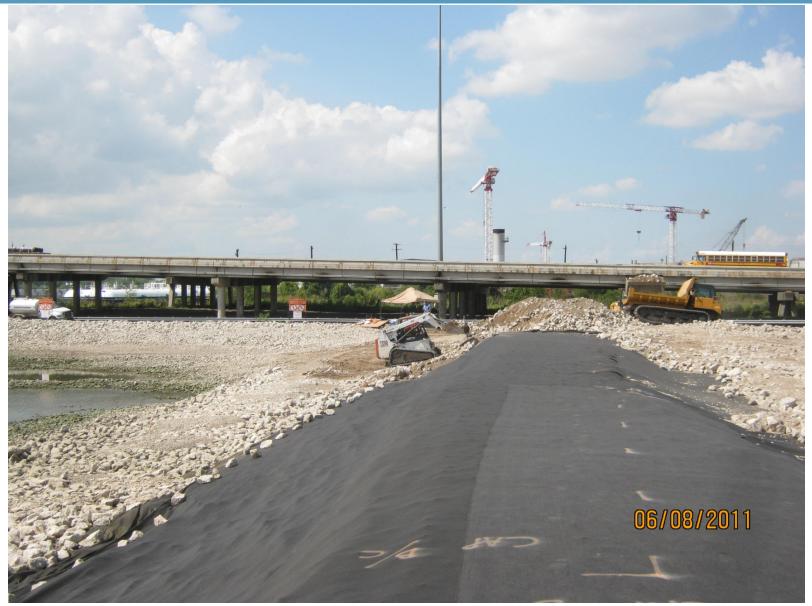
Looking south toward the stockpile area.

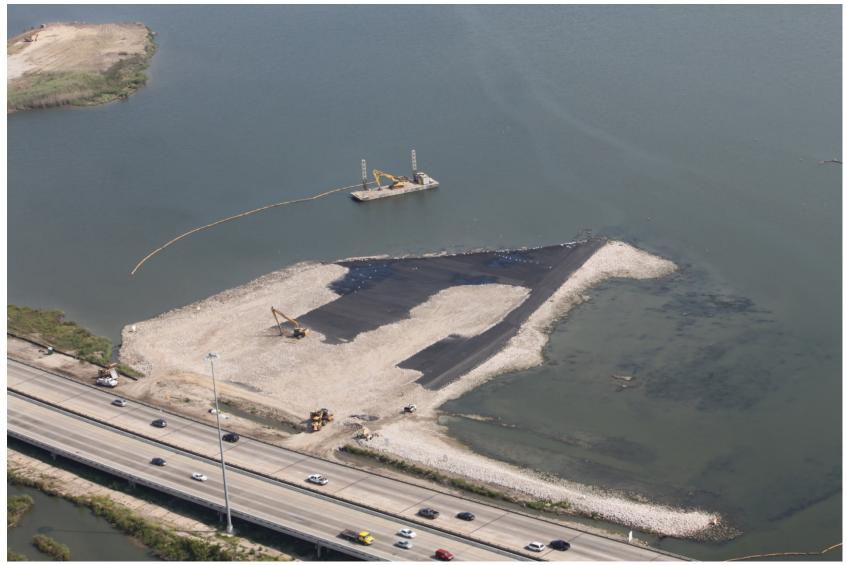
The attached photographs (Figures 2 - 9) taken during and immediately after construction show the subject area and document the installation of the different geotextile layers and armor rock. What was observed during the recent Site inspection were small patches of the separation layer of geotextile, specifically installed for protection during construction. The separation geotextile is plainly visible on top of the protective armored cap in Figures 5 and 6 attached and remnants, similar to what was observed during the recent Site inspection, remained visible immediately following construction. The recent storm events and

Note separation layer of geotextile utilized for the stockpile area during construction is shown lying over the protective armored cap.

As requested in the Memo to File, Respondents will place additional rock in the subject area in the near future as a cosmetic measure to prevent the separation geotextile layer from being observed at the surface. Our intent is to use armor rock C that is currently stockpiled at a nearby facility for use in maintenance of the armored cap. It is estimated that this effort will require approximately one cubic yard or less of material. The material will be installed using hand tools. Coordination of this effort, along with additional vegetation control by Benchmark Ecological Services, is complete at this point and we received your concurrence for the maintenance and vegetation control in an email to me on June 19, 2015.

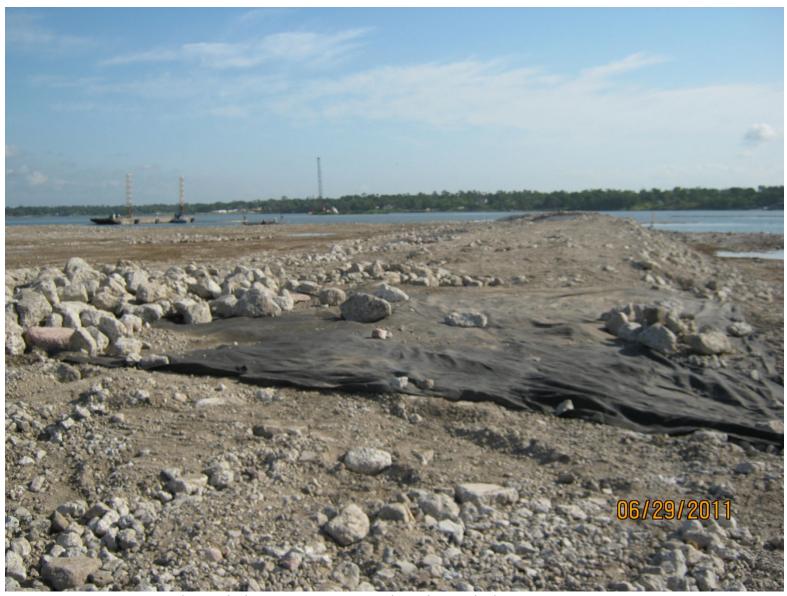
Note protective armor cap beneath the separation geotextile in the stockpile area.

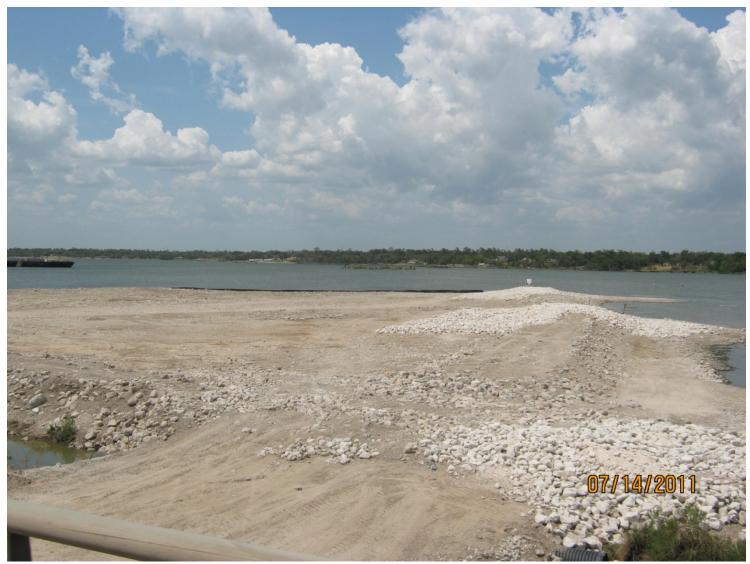
Note reddish colored processed concrete aggregates in the stockpile area.

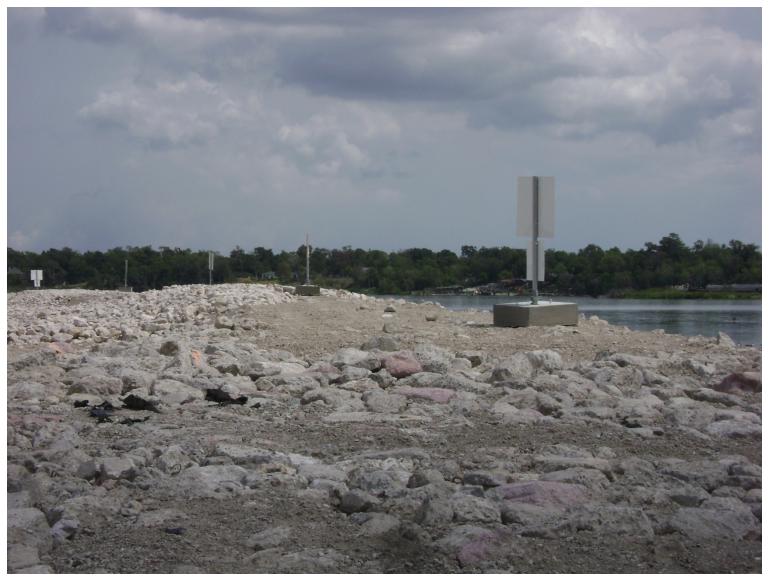
Note signage and reddish colored processed concrete aggregate along the central berm with remanent geotextile from multiple laps for the 12 ounce geotextile underlayer, geomembrane, 16 ounce cushion layer, and the final layer of geotextile and armor stone.
